Survey Report

[Property Address]

Description	Converted flat located at ground and basement level in a four storey and basement corner tenement building.
Accommodation	GROUND FLOOR: Shared Entrance Vestibule, Living Room, Kitchen/Dining Room BASEMENT LEVEL: Hallway, Bedroom 1 with en-suite Bathroom and Study off, Bedroom 2, Bedroom 3 and Shower Compartment
Gross internal floor area (m²)	166.7m ²
Neighbourhood and location	The property is located in the New Town area of Edinburgh close to the City Centre and to all local amenities and facilities.
Age	The subject property is aged in the region of 190 years old.

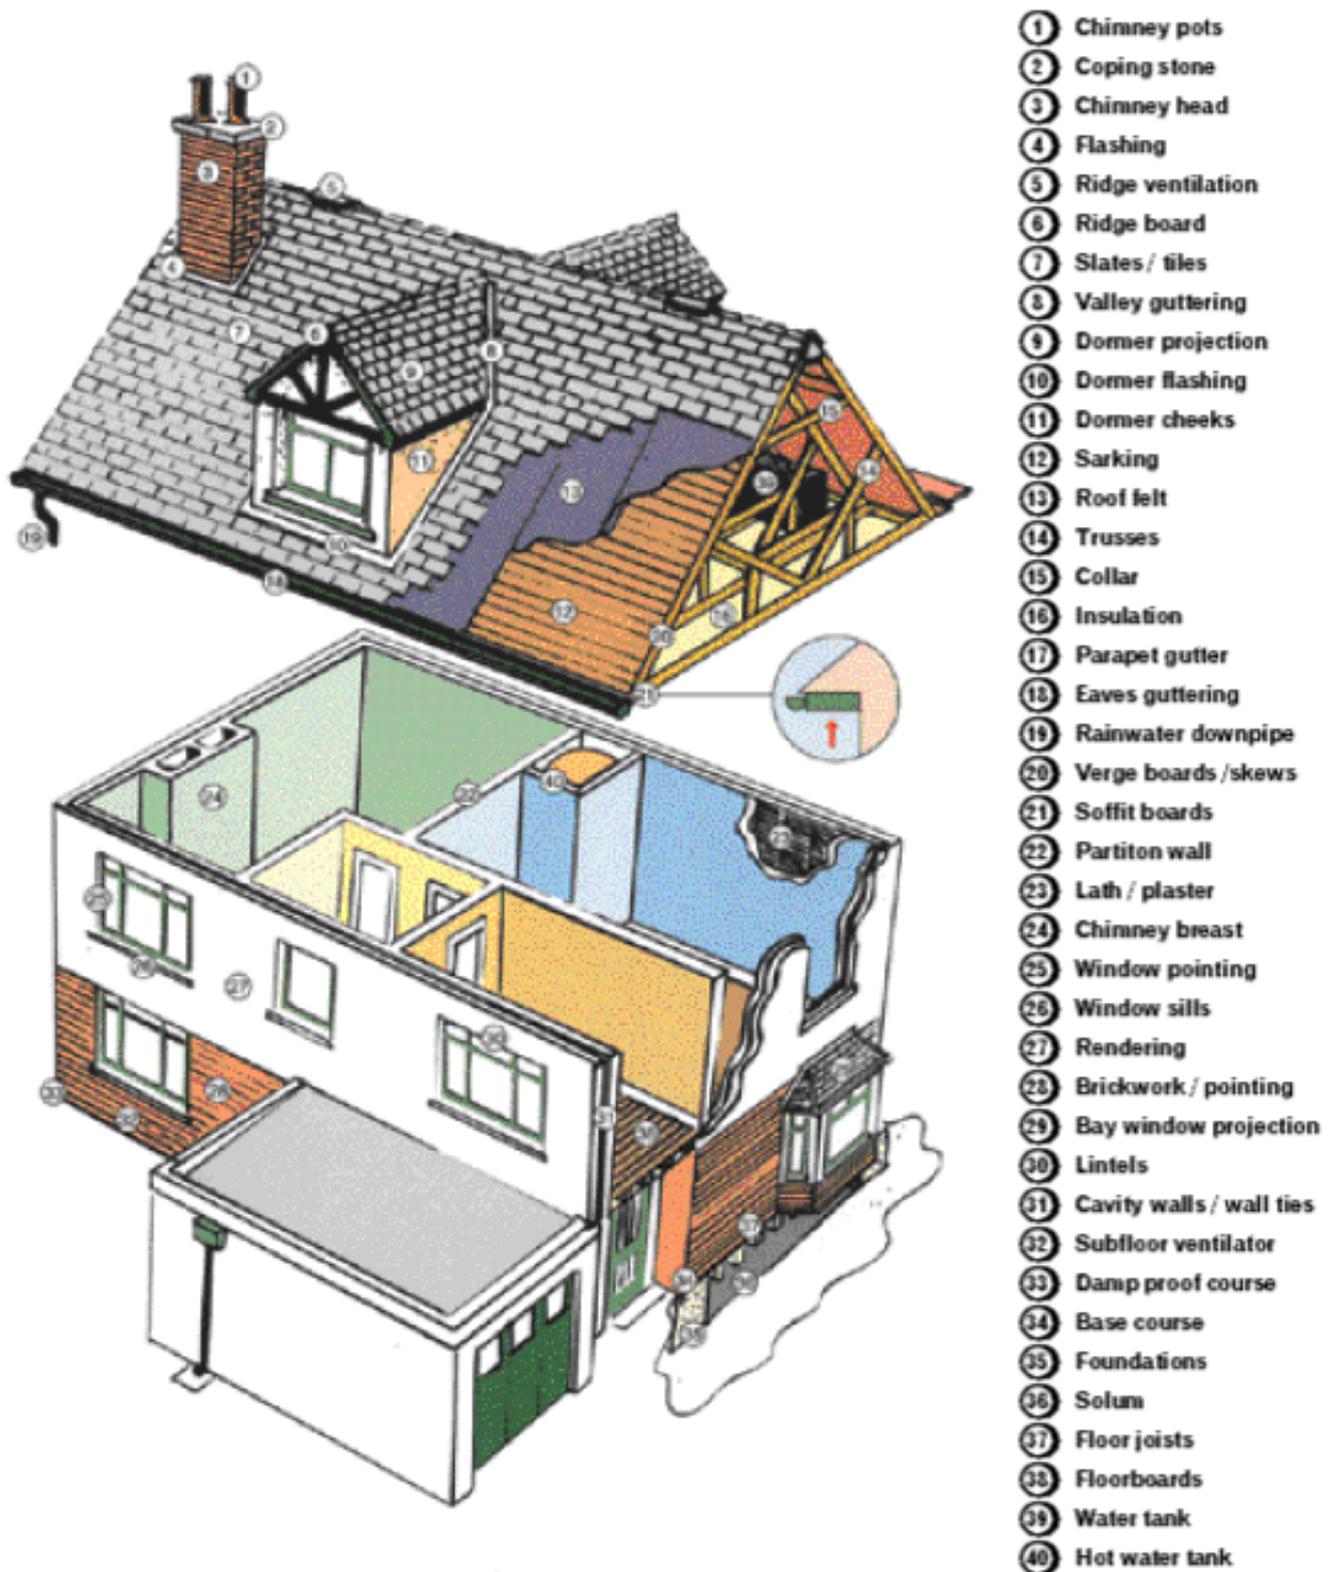
Sectional diagram showing elements of a typical house

Reference may be made in this report to some or all of the above component parts of the property. This diagram may assist you in locating and understanding these terms.
